CENTER CONSOLE ASSEMBLY

< ON-VEHICLE REPAIR >

Exploded View

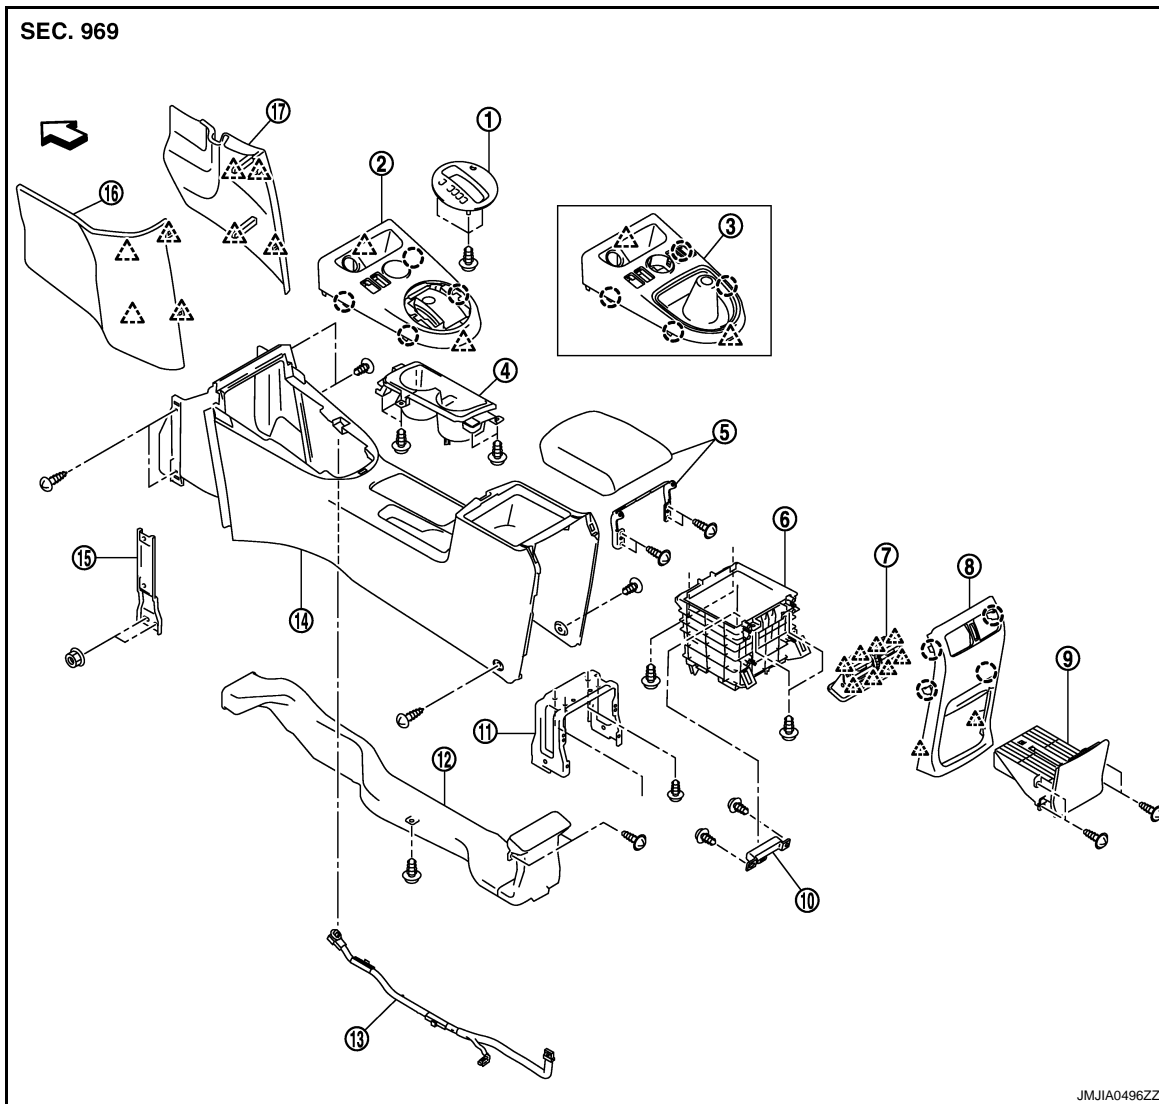
CENTER CONSOLE

| 1. Indicator assembly (AT/CVT models) | 2. Console finisher assembly (AT/CVT models) | 3. Console finisher assembly (MT models) |
| 4. Cup holder assembly | 5. Console lid assembly | 6. Console box assembly |
| 7. Rear ventilator grille | 8. Console rear finisher | 9. Rear cup holder assembly |
| 10. Inside key antenna | 11. Console rear bracket | 12. Rear ventilator duct |
| 13. Console sub harness | 14. Console body | 15. Console bracket |
| 16. Instrument lower cover (LH) | 17. Instrument lower cover (RH) | |

○ : Clip

△ : Pawl

□ : Metal clip
